**Flood Control Project Maintenance  
Levee Inspections**

**Spring 2016 Levee Inspection Results**

**Yolo County Service Area 6**

Waterway				Bank	Unit Miles
Unit No. 01 Right Bank of Sacramento River at Knights Landing				Right	5.87
	Spring (March - May)	Summer (June - August)	(September - November) Fall	Winter (December - February)	
Unit Maintenance Rating (Fall Only)					
Date of Inspection	4/12/2016 - 4/12/2016				
DWR Inspector	Jai Lor				
Accompanied By

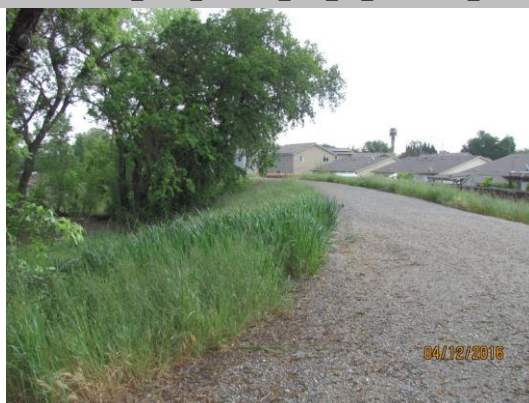
Photo 1 of 1 : SP\_2016\_NA0022\_350\_68\_20160413\_00142.jpg

View of the vegetation on the waterward side of the levee looking downstream. Spring 2016.

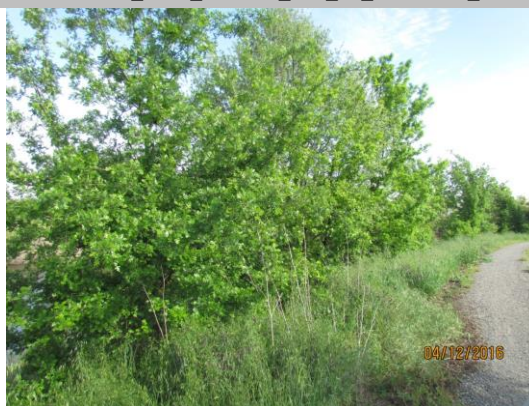
Photo 1 of 1 : SP\_2016\_NA0022\_350\_66\_20160413\_00144.jpg

View of the oak trees on the waterward side of the levee looking downstream. Spring 2016.

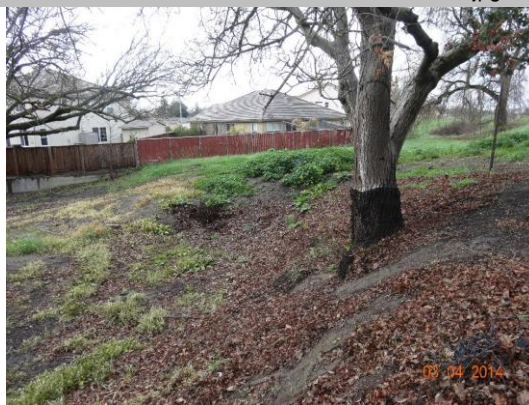
Photo 1 of 2 : UCIP\_SP\_2016\_31903\_58222.jpg

LM Start	0.13	Rating **	M	Issue No.	402
LM End	0.13	Issue Type +	En	Location *	LS
Category	Supplemental			GPS Latitude/Longitude	
				Start	End
Item	DWR UCIP Field Study			38.800647 °	38.800647 °
				-121.723212 °	-121.723212 °
DWR ID					
Comment Code					
Inspector Comment					
FS_ID:31903 DS_ID:19515 EP_NO: 9425 Repair Type: Non-Urgent Crossing Status: Found UCIP Comments: Need to properly abandon crossing per Title 23-- pipe has been disconnected. No signs of pipe visible on waterward and landward sides. Need to contact owner to determine additional information about pipe section through levee. FIELD_STRUCT_DESC: Abandoned 8-inch steel pipe through the levee, 3.0-feet below the crown. Pump structure in channel. (ABO Permit No. 9425-1974). FS Date: 3/4/2014

View of landward side.

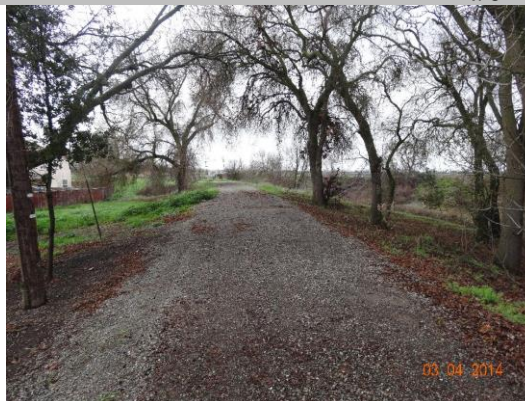
Photo 2 of 2 : UCIP\_SP\_2016\_31903\_58221.jpg

LM Start	0.13	Rating **	M	Issue No.	402 (cont)	
LM End	0.13	Issue Type +	En	Location *	LS	
Category	Supplemental			GPS Latitude/Longitude		
				Start		End
Item	DWR UCIP Field Study			38.800647 °		38.800647 °
				-121.723212 °		-121.723212 °
DWR ID						
Comment Code						
Inspector Comment						
FS_ID:31903						
DS_ID:19515						
EP_NO: 9425						
Repair Type: Non-Urgent						
Crossing Status: Found						
UCIP Comments: Need to properly abandon crossing per Title 23-- pipe has been disconnected. No signs of pipe visible on waterward and landward sides. Need to contact owner to determine additional information about pipe section through levee.						
FIELD_STRUCT_DESC: Abandoned 8-inch steel pipe through the levee, 3.0-feet below the crown. Pump structure in channel. (ABO Permit No. 9425-1974).						
FS Date: 3/4/2014

Overview of levee crown looking at crossing.

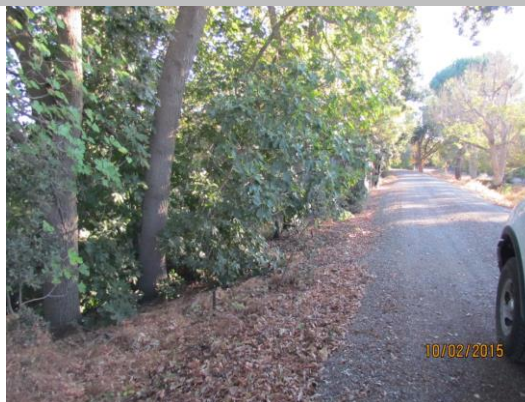
Photo 1 of 1 : SP\_2016\_NA0022\_350\_6\_20160304\_00007.jpg

LM Start	0.13	Rating **	M	Issue No.	6
LM End	0.20	Issue Type +	Ma	Location *	WS
Category	Earthen Levee			GPS Latitude/Longitude	
				Start	End
Item	Trim / Thin Trees			38.800645 °	38.801336 °
				-121.723172 °	-121.722106 °
DWR ID	DWR_NA0022_01_s_2012_6				
Comment Code					
T3 : Trim and thin trees to allow visibility of the ground and room to flood fight.					
Inspector Comment					
Trim trees to allow visibility.

View of the vegetation and trees on the waterward side of the levee looking downstream. Fall 2015.

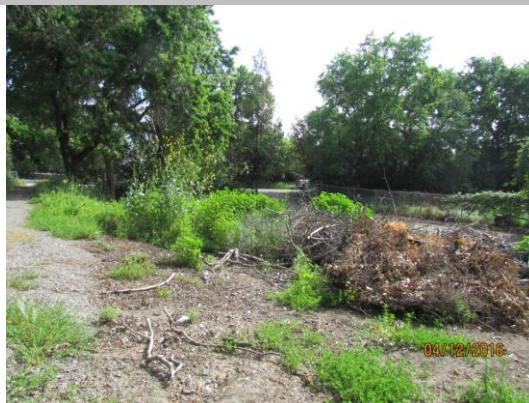
Photo 1 of 1 : SP\_2016\_NA0022\_350\_29\_20160413\_00145.jpg

View of the pruning pile looking downstream. Spring 2016.

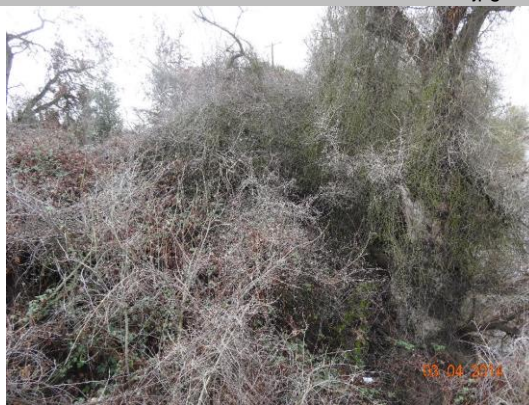
Photo 2 of 2 : UCIP\_SP\_2016\_31904\_58227.jpg

LM Start	0.21	Rating **	M	Issue No.	403
LM End	0.21	Issue Type +	En	Location *	LS
Category	Supplemental			GPS Latitude/Longitude	
				Start	End
Item	DWR UCIP Field Study			38.801280 °	38.801280 °
				-121.722000 °	-121.722000 °
DWR ID					
Comment Code					
Inspector Comment					
FS_ID:31904					
DS_ID:19516					
EP_NO: N/A					
Repair Type: Non-Urgent					
Crossing Status: Indicator Found					
UCIP Comments: Need to properly abandon per Title 23 if corssing is no longer used--debris inside concrete box and near site. Need to contact owner.					
FIELD_STRUCT_DESC: 48-inch CM pipe through the levee, 14.5-feet below the crown. Slide gate in concrete box on the waterward bank. (ABO Permit - 1976).					
FS Date: 3/4/2014

View of waterward toe photo taken from bridge.

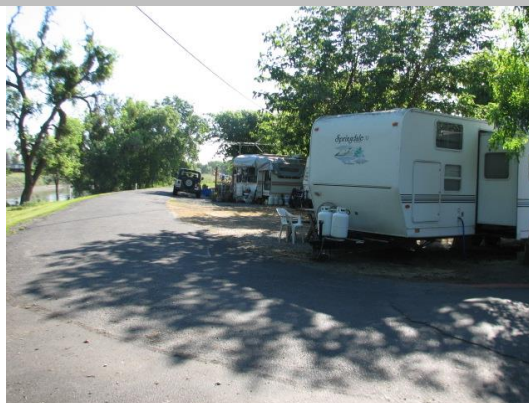
Photo 2 of 2 : SP\_2016\_NA0022\_350\_28\_20160304\_00027.jpg

Trailers on the crown of the levee. Spring 2014

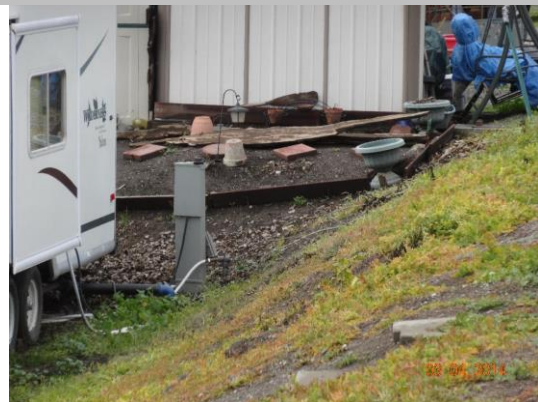
Photo 2 of 2 : UCIP\_SP\_2016\_45403\_60804.jpg

LM Start	0.26	Rating **	M	Issue No.	421
LM End	0.26	Issue Type +	En	Location *	LS
Category	Supplemental			GPS Latitude/Longitude	
				Start	End
Item	DWR UCIP Field Study			38.801597 °	38.801597 °
				-121.721226 °	-121.721226 °
DWR ID					
Comment Code					
Inspector Comment					
FS_ID:45403 DS_ID:19513 EP_NO: 9424 Repair Type: Non-Urgent Crossing Status: Indicator Found UCIP Comments: Unable to determine alignment of crossing--it's either through levee or along landward side. It appears that the waterline goes along landward side. Need to contact owner to obtain additional information about crossing. 2 inch metal pipe sticking out at the waterward berm edge. FIELD_STRUCT_DESC: Water pipe through the levee. Faucets in the landward slope. (ABO Permit No. 9424-1974). FS Date: 3/4/2014

Spigot located on landward toe.

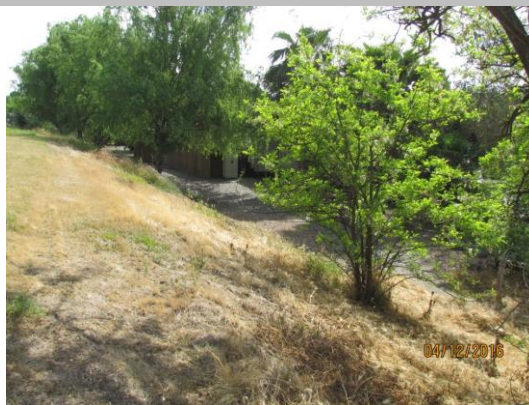
Photo 2 of 2 : SP\_2016\_NA0022\_350\_27\_20160413\_00146.jpg

Tree is at levee mile 0.30 . Spring 2016.

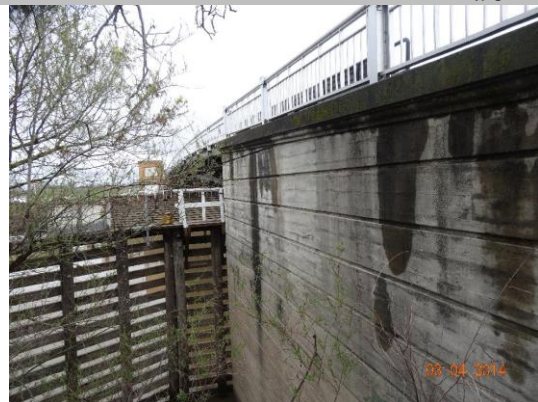
Photo 2 of 2 : UCIP\_SP\_2016\_31906\_58237.jpg

Comment Code						
Inspector Comment						
FS_ID:31906 DS_ID:19534 EP_NO: 17016 Repair Type: Non-Urgent Crossing Status: Indicator Found UCIP Comments: Unable to confirm crossing alignment--steel pipe visible on waterward side however, unable to confirm if crossing is the same one found during field confirmation. Need to contact owner to verify alignment and status of crossing. Slope was too steep to verify and obtain additional information about pipe. FIELD_STRUCT_DESC: Three 2-inch diameter and three 1.5-inch diameter fiber optic conduits through the levee, encased in a single HDPE conduit, 30-feet below the levee crown. Concrete caps on both ends of the casing, on the landward and waterward sides. Voids in the HDPE conduit grouted. (Permit No. 17016-2000). FS Date: 3/4/2014

No pipe attached along bridge.

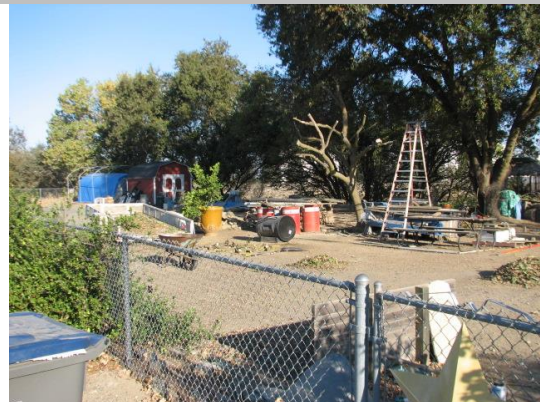
Photo 1 of 1 : SP\_2016\_NA0022\_350\_395\_20160304\_00074.jpg

Material blocking visibility on the waterside of the levee. Fall 2013

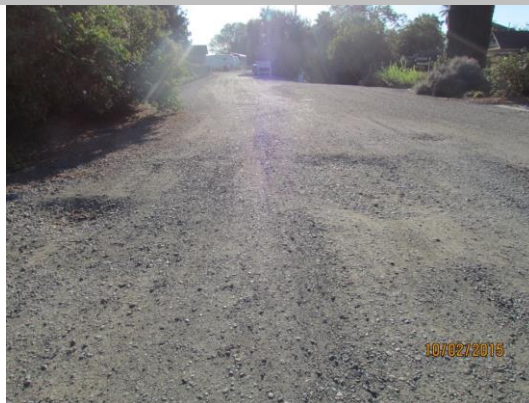
Photo 1 of 1 : SP\_2016\_NA0022\_350\_69\_20160304\_00048.jpg

LM Start	0.53	Rating **	M	Issue No.	69
LM End	0.53	Issue Type +	Ma	Location *	CR
Category	Earthen Levee			GPS Latitude/Longitude	
				Start	End
Item	Crown Surface / Depressions / Rutting			38.801950 °	38.801950 °
				-121.716299 °	-121.716299 °
DWR ID	DWR_NA0022_01_f_2015_69				
Comment Code					
C2 : Repair depressions or ruts in the crown or slope.					
Inspector Comment

View of the depression on the crown of the levee looking downstream.  
Fall 2015.

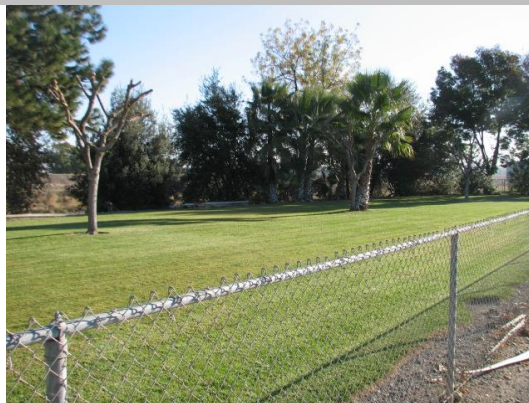
Photo 1 of 1 : SP\_2016\_NA0022\_350\_24\_20160304\_00022.jpg

The lawn area is on the levee waterside and crown. Fall 2013

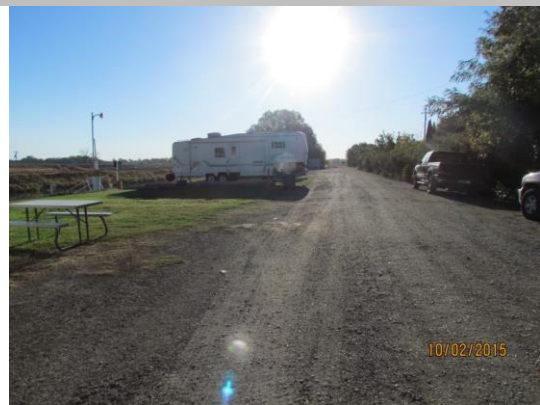
Photo 1 of 1 : SP\_2016\_NA0022\_350\_23\_20160304\_00021.jpg

LM Start	0.55	Rating **	M	Issue No.	415
LM End	0.55	Issue Type +	En	Location *	WS
Category	Supplemental			GPS Latitude/Longitude	
				Start	End
Item	DWR UCIP Field Study			38.801855 °	38.801855 °
				-121.716003 °	-121.716003 °
DWR ID					
Comment Code					
Inspector Comment					
FS_ID:38995 DS_ID:19553 EP_NO: 17649 Repair Type: Non-Urgent Crossing Status: Not Found UCIP Comments: 1 inch line visible on landward side (38.801855, -121.716003) unable to confirm if line is the line authorized. Need to contact owner to confirm installation and size. FIELD_STRUCT_DESC: 2 of 2: 1.5-inch diameter water line through the levee, buried 2-feet below the levee crown. (Permit No. 17649-2004) FS Date: 3/4/2014

View of the Yacht club on the crown of the levee looking downstream.  
Fall 2015.

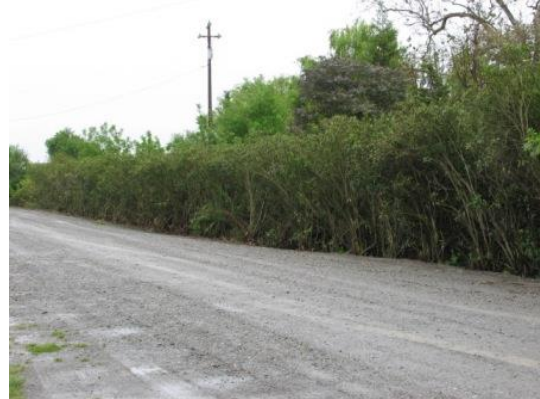
Photo 1 of 1 : SP\_2016\_NA0022\_350\_22\_20160304\_00020.jpg

Oleanders along the shoulder.

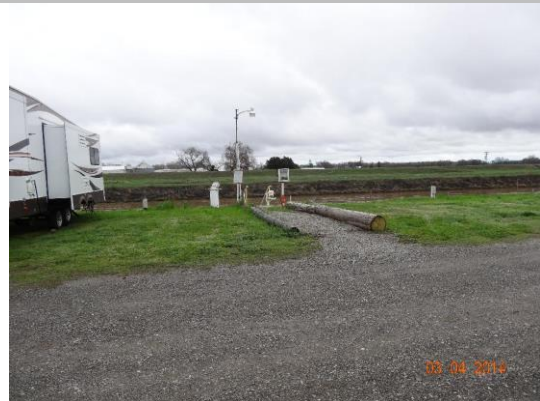
Photo 1 of 2 : UCIP\_SP\_2016\_38188\_69562.jpg

LM Start	0.57	Rating **	M	Issue No.	419
LM End	0.57	Issue Type +	En	Location *	LS
Category	Supplemental			GPS Latitude/Longitude	
				Start	End
Item	DWR UCIP Field Study			38.801798 °	38.801798 °
				-121.715584 °	-121.715584 °
DWR ID					
Comment Code					
Inspector Comment					
FS_ID:38188 DS_ID:19519 EP_NO: N/A Repair Type: Non-Urgent Crossing Status: Indicator Found UCIP Comments: Unable to find any signs of crossing on waterward side. Signs of concrete riser visible on landward side. If crossing is abandoned owner will need to coordinate with the Central Valley Flood Protection Board (CVFPB) for Title 23 requirements. FIELD_STRUCT_DESC: 10-inch pipe through the levee, 3.3 feet below the crown. Plate welded on waterward end (1975). 24-inch concrete riser on the landward side. FS Date: 3/4/2014

View of waterward side.

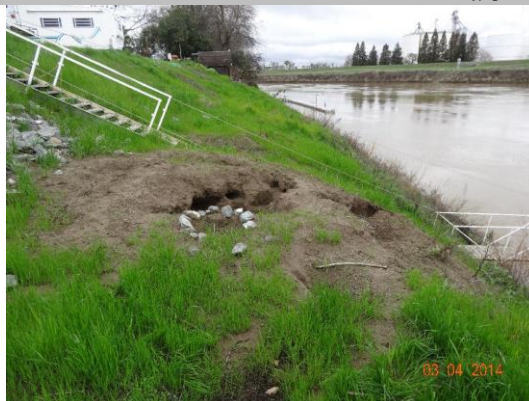
Photo 2 of 2 : UCIP\_SP\_2016\_38188\_69560.jpg

LM Start	0.57	Rating **	M	Issue No.	419 (cont)	
LM End	0.57	Issue Type +	En	Location *	LS	
Category	Supplemental			GPS Latitude/Longitude		
				Start		End
Item	DWR UCIP Field Study			38.801798 °		38.801798 °
				-121.715584 °		-121.715584 °
DWR ID						
Comment Code						
Inspector Comment						
FS_ID:38188						
DS_ID:19519						
EP_NO: N/A						
Repair Type: Non-Urgent						
Crossing Status: Indicator Found						
UCIP Comments: Unable to find any signs of crossing on waterward side. Signs of concrete riser visible on landward side. If crossing is abandoned owner will need to coordinate with the Central Valley Flood Protection Board (CVFPB) for Title 23 requirements.						
FIELD_STRUCT_DESC: 10-inch pipe through the levee, 3.3 feet below the crown. Plate welded on waterward end (1975). 24-inch concrete riser on the landward side.						
FS Date: 3/4/2014

View of waterward slope. Large hole visible on waterward side.

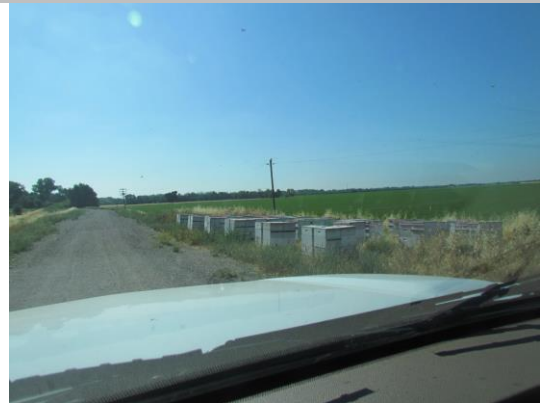
Photo 1 of 1 : SP\_2016\_NA0022\_350\_73\_20160304\_00052.jpg

View of the beehives on the landward side of the levee looking downstream. Spring 2015.

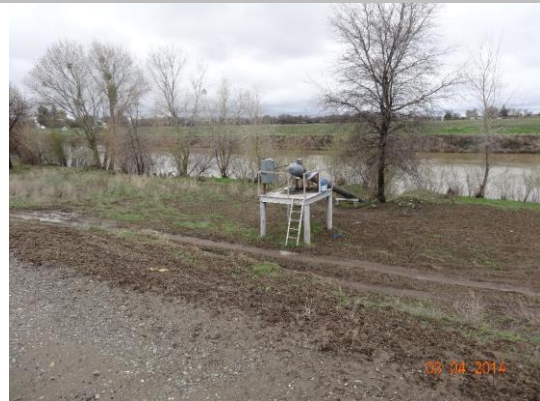
Photo 1 of 2 : UCIP\_SP\_2016\_31969\_58410.jpg

LM Start	0.93	Rating **	M	Issue No.	410
LM End	0.93	Issue Type +	En	Location *	LS
Category	Supplemental			GPS Latitude/Longitude	
				Start	End
Item	DWR UCIP Field Study			38.800200 °	38.800200 °
				-121.709258 °	-121.709258 °
DWR ID					
Comment Code					
Inspector Comment					
FS_ID:31969 DS_ID:19540 EP_NO: N/A Repair Type: Non-Urgent Crossing Status: Found UCIP Comments: Pipe section on waterward side appears to have been removed and reinstalled--Need to contact owner to obtain additional information regarding work completed. FIELD_STRUCT_DESC: 14-inch steel drain pipe through the levee. Pump and valve on waterside bank. (USACE-1953). This entry matches the Drainage or Irrigation Structure referenced in O&M manual (Station 266+72.2). Pipe and pump completely replaced under Permit No. 3798 (1962). FS Date: 3/4/2014

View of waterward side.

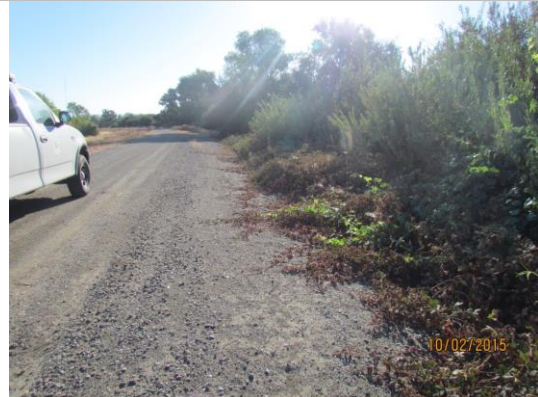
Photo 1 of 1 : SP\_2016\_NA0022\_350\_21\_20160304\_00019.jpg

View of the vegetation on the landward side of the levee looking downstream. Fall 2015.

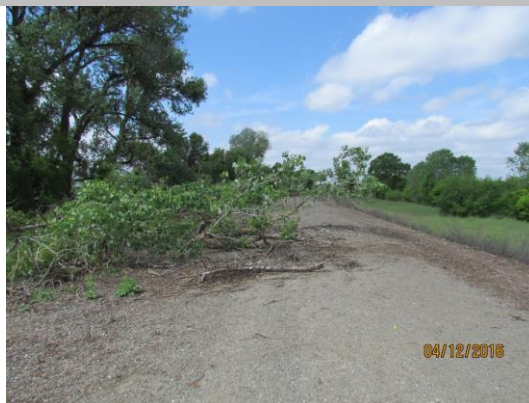
Photo 1 of 1 : SP\_2016\_NA0022\_350\_109\_20160413\_00152.jpg

View of the tree blocking the crown of the levee looking upstream. Spring 2016.

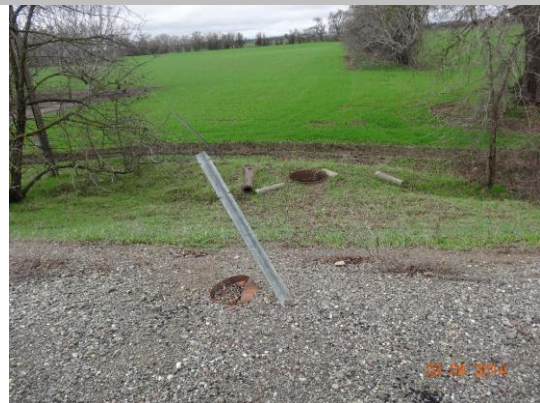
Photo 1 of 2 : UCIP\_SP\_2016\_31912\_58261.jpg

Comment Code					
Inspector Comment					
FS_ID:31912 DS_ID:19522 EP_NO: 6296 Repair Type: Non-Urgent Crossing Status: Found UCIP Comments: Siphon breaker housing on landward slope unit damaged and debris scattered on landward side. Unable to determine if crossing is still in use. Need to contact owner to determine status of crossing. FIELD_STRUCT_DESC: 12-inch (not 14 inch as indicated in desk study) drain pipe through the levee, 11.8-feet below the crown. 1.25 electrical conduit through the levee. Electrical control panel on waterward slope. Slant pump, mounted on steel structure on the waterward bank. Siphon breaker on the landward shoulder. Standard CM cutoff wall around pipe at centerline of levee. Pipe extends from pump to existing irrigation ditch at landward toe. (Permit No. 6296-1968) FS Date: 3/4/2014

View of landward side.

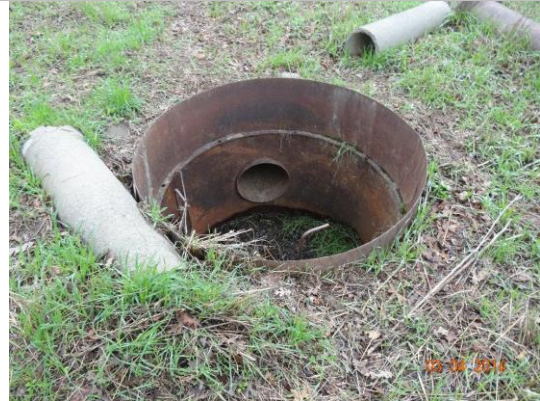
Photo 2 of 2 : UCIP\_SP\_2016\_31912\_58260.jpg

Item	DWR UCIP Field Study			38.798388 °	38.798388 °	
				-121.698145 °	-121.698145 °	
DWR ID						
Comment Code						
Inspector Comment						
FS_ID:31912						
DS_ID:19522						
EP_NO: 6296						
Repair Type: Non-Urgent						
Crossing Status: Found						
UCIP Comments: Siphon breaker housing on landward slope unit damaged and debris scattered on landward side. Unable to determine if crossing is still in use. Need to contact owner to determine status of crossing.						
FIELD_STRUCT_DESC: 12-inch (not 14 inch as indicated in desk study) drain pipe through the levee, 11.8-feet below the crown. 1.25 electrical conduit through the levee. Electrical control panel on waterward slope. Slant pump, mounted on steel structure on the waterward bank. Siphon breaker on the landward shoulder. Standard CM cutoff wall around pipe at centerline of levee. Pipe extends from pump to existing irrigation ditch at landward toe. (Permit No. 6296-1968)

Riser on landward toe.

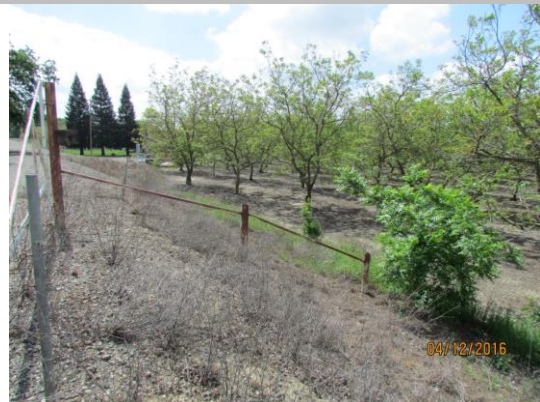
Photo 1 of 1 : SP\_2016\_NA0022\_350\_112\_20160413\_00153.jpg

View of the tree at the toe of the levee on the landward side looking downstream. Spring 2016.

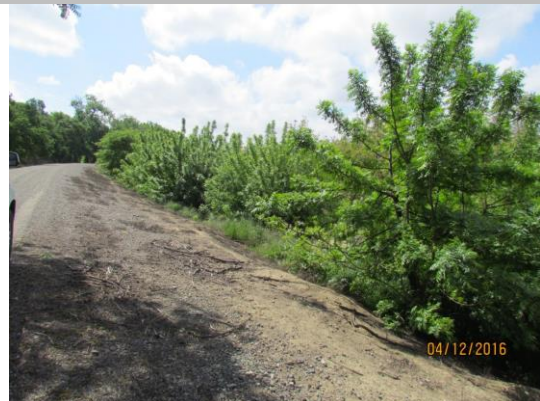
Photo 1 of 1 : SP\_2016\_NA0022\_350\_116\_20160413\_00154.jpg

View of the trees on the waterward side of the levee looking downstream. Spring 2016.

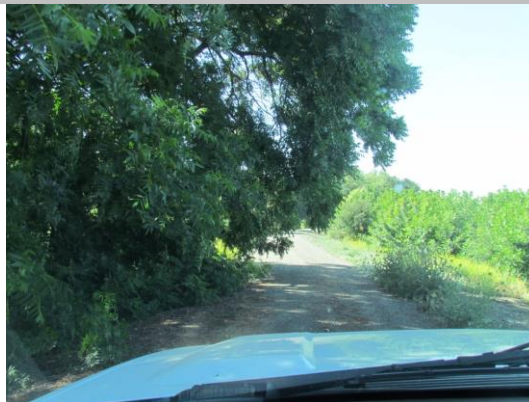
Photo 1 of 1 : SP\_2016\_NA0022\_350\_74\_20160304\_00053.jpg

View of the trees on the crown of the levee looking downstream. Spring 2015.

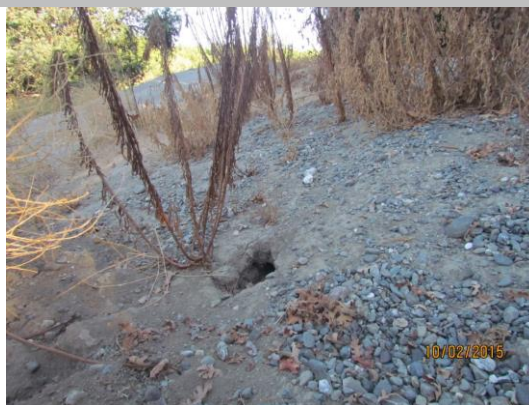
Photo 1 of 1 : SP\_2016\_NA0022\_350\_8\_20160304\_00009.jpg

View of the rodent hole on the landward side of the levee looking downstream. Fall 2015.

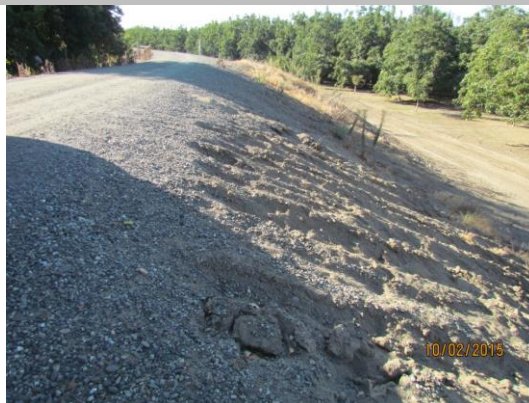
Photo 1 of 1 : SP\_2016\_NA0022\_350\_93\_20160304\_00067.jpg

View of the slope stability on the landward side of the levee looking downstream. Fall 2015.

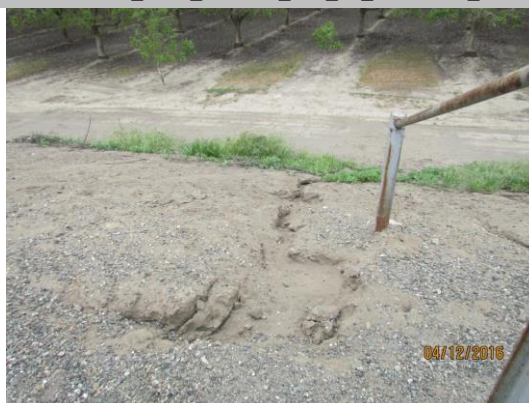
Photo 1 of 2 : SP\_2016\_NA0022\_350\_35\_20160413\_00157.jpg

Erosion is on the landward side of the levee. Spring 2016.

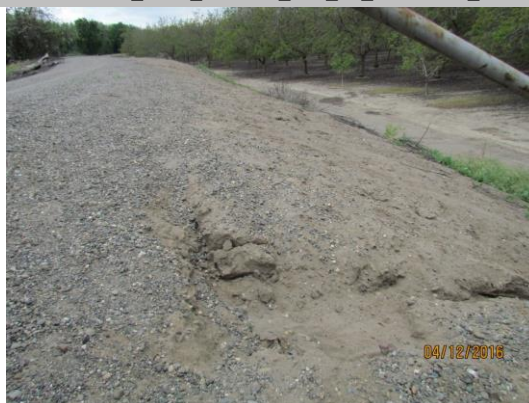
Photo 2 of 2 : SP\_2016\_NA0022\_350\_35\_20160413\_00158.jpg

Perspective view of the erosion on the landward side of the levee. Spring 2016.

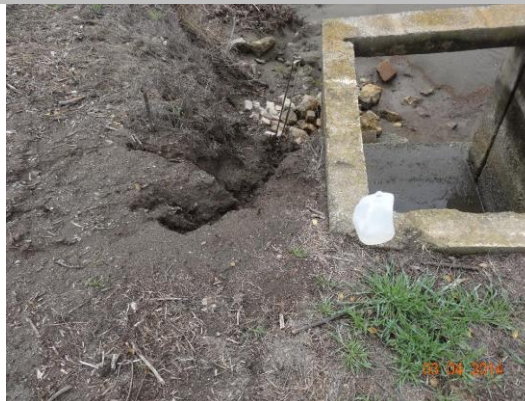
Photo 2 of 2 : UCIP\_SP\_2016\_31634\_57914.jpg

Slope erosion near concrete box.

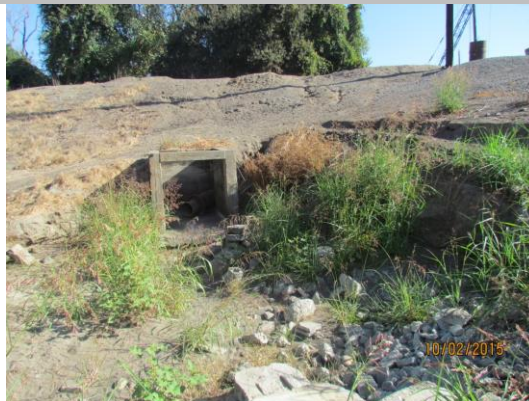
Photo 3 of 3 : SP\_2016\_NA0022\_350\_96\_20160304\_00072.jpg

The erosion is within the levee prism. Fall 2015.

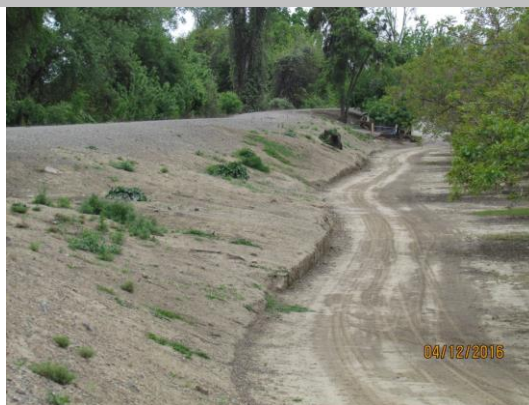
Photo 1 of 1 : SP\_2016\_NA0022\_350\_94\_20160413\_00159.jpg

View of the cut at the levee toe on the landward side looking downstream. Spring 2016.

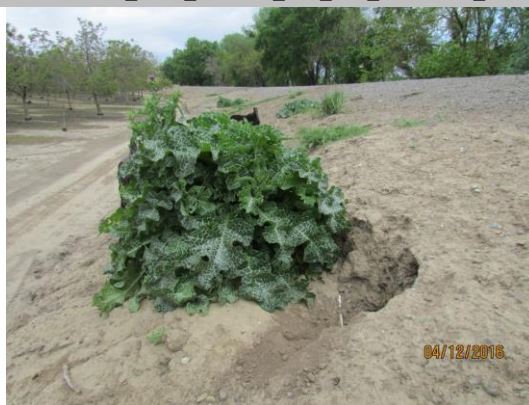
Photo 2 of 2 : SP\_2016\_NA0022\_350\_123\_20160413\_00162.jpg

Perspective view of the rodent hole looking upstream. Spring 2016.

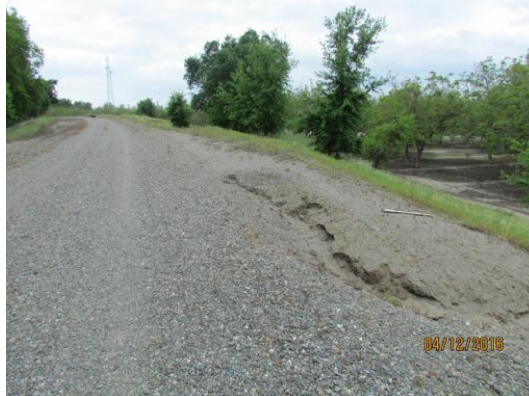
Photo 1 of 1 : SP\_2016\_NA0022\_350\_87\_20160413\_00164.jpg

View of the erosion on the landward side of the levee looking downstream. Spring 2016.

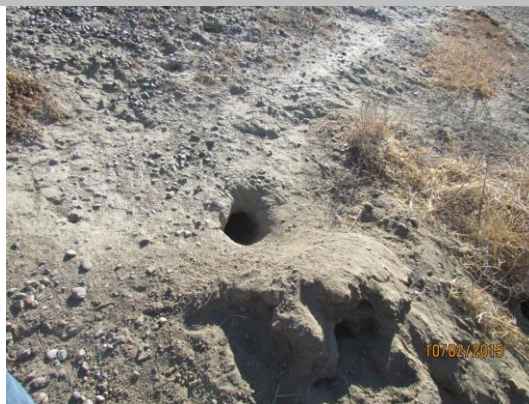
Photo 2 of 2 : SP\_2016\_NA0022\_350\_52\_20160304\_00045.jpg

There are multiple rodent holes in this area. Fall 2015.

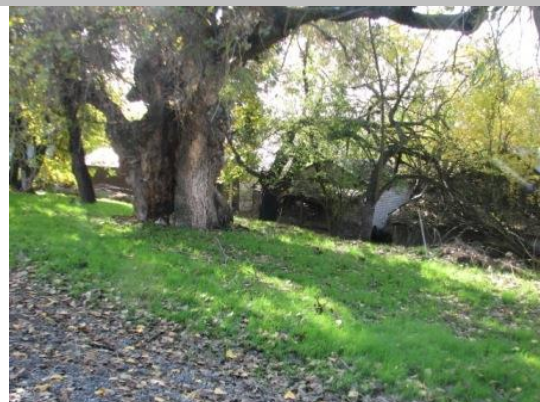
Photo 1 of 2 : SP\_2016\_NA0022\_350\_12\_20160304\_00012.jpg

Buildings are located at the toe of the levee. Fall 2012

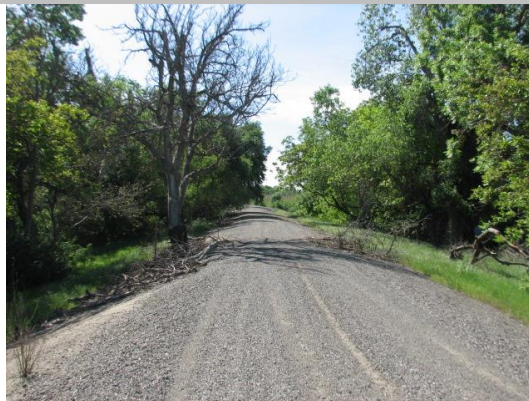
Photo 1 of 1 : SP\_2016\_NA0022\_350\_43\_20160304\_00038.jpg

A tree is dying and needs to be monitored as it may pose a threat to the levee. Spring 2014

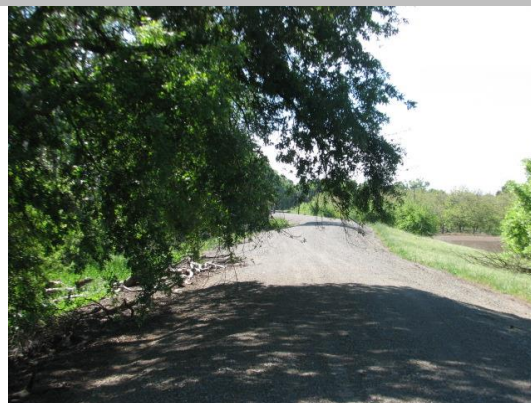
Photo 1 of 1 : SP\_2016\_NA0022\_350\_46\_20160304\_00041.jpg

Trees need to be trimmed up to at least 12 feet above the crown. Spring 2014

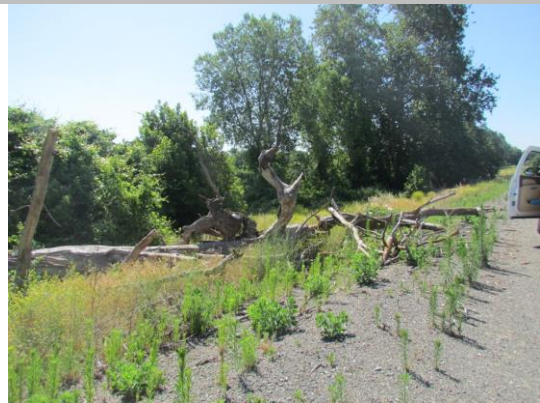
Photo 2 of 2 : SP\_2016\_NA0022\_350\_47\_20160304\_00043.jpg

View of the fallen tree on the waterward side of the levee looking  
downstream. Spring 2015.

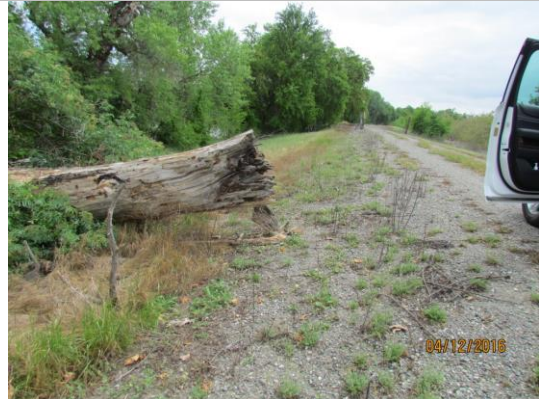
Photo 1 of 1 : SP\_2016\_NA0022\_350\_15\_20160413\_00165.jpg

View of the fallen tree on the waterward slope of the levee looking downstream. Spring 2016.

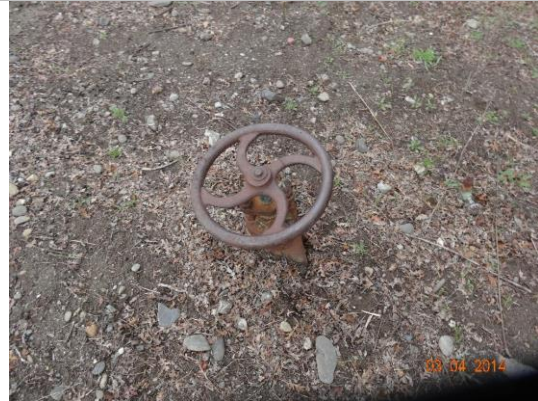
Photo 2 of 2 : UCIP\_SP\_2016\_39858\_71840.jpg

Positive closure device is buried on waterward side.

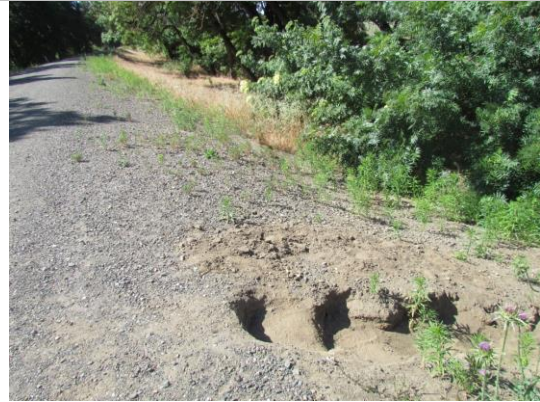
Photo 1 of 2 : SP\_2016\_NA0022\_350\_79\_20160304\_00055.jpg

View of the stairs on the landward side of the levee looking downstream. Spring 2015.

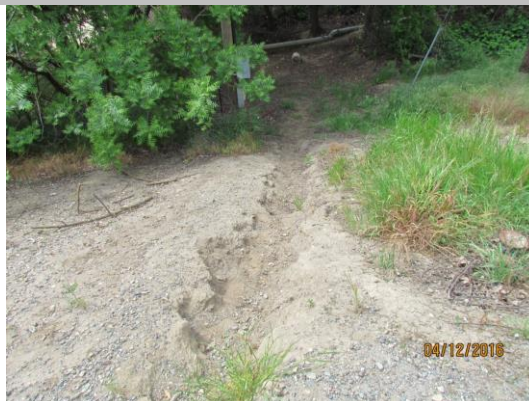
Photo 2 of 2 : SP\_2016\_NA0022\_350\_79\_20160413\_00166.jpg

Dirt stairs has eroded and caused a slope stability. Spring 2016.

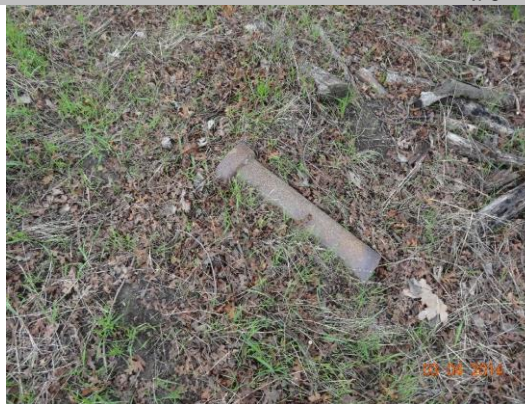
Photo 2 of 2 : UCIP\_SP\_2016\_38996\_69567.jpg

Debris scattered on landward side.

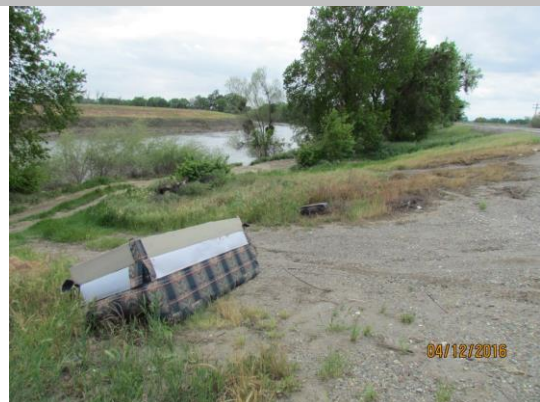
Photo 1 of 1 : SP\_2016\_NA0022\_350\_98\_20160413\_00167.jpg

View of the couch on the waterward side of the levee looking downstream. Spring 2016.

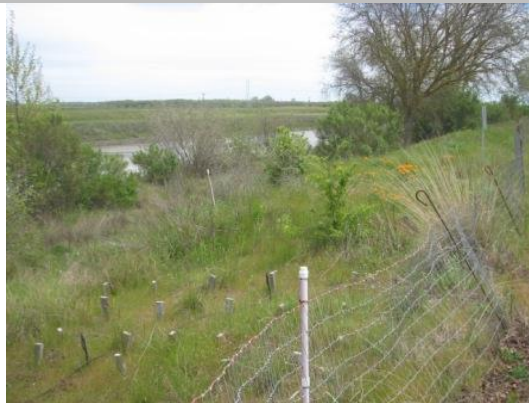
Photo 2 of 2 : SP\_2016\_NA0022\_350\_36\_20160304\_00033.jpg

Fence, irrigation and stakes in the revegetation site.

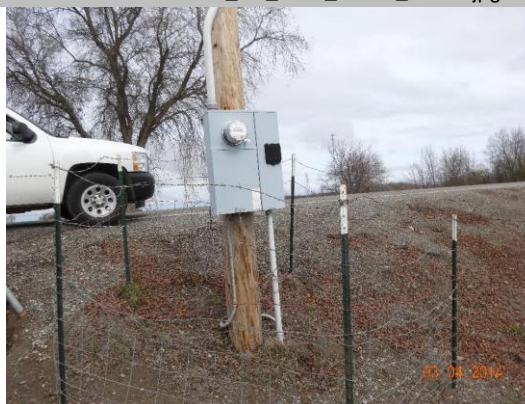
Photo 2 of 2 : UCIP\_SP\_2016\_42864\_69572.jpg

Power pole with conduit line through levee.

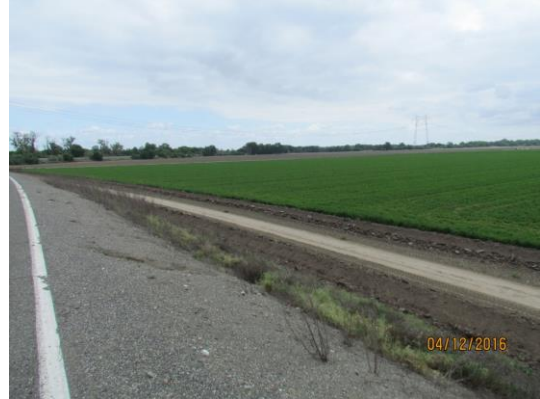
Photo 2 of 2 : SP\_2016\_NA0022\_350\_138\_20160413\_00170.jpg

Perspective view of the ditch on the landward side of the levee looking downstream. Spring 2016.

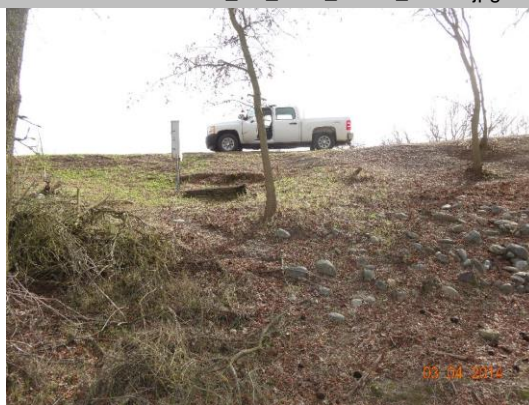
Photo 2 of 2 : UCIP\_SP\_2016\_31927\_58331.jpg

Rip rap along waterward slope.

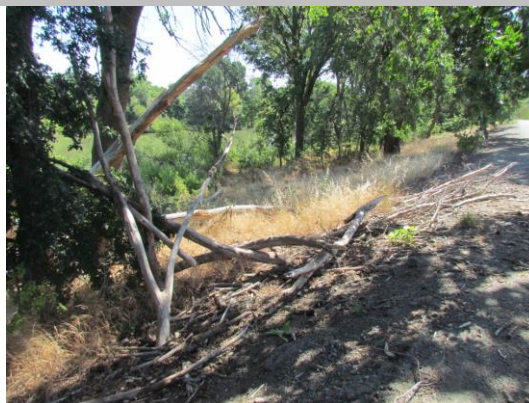
Photo 1 of 1 : SP\_2016\_NA0022\_350\_83\_20160304\_00058.jpg

View of the tree and tree limbs on the waterward side of the levee looking downstream. Spring 2015.

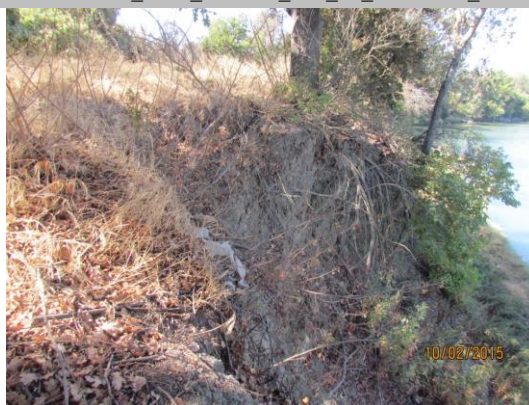
Photo 1 of 2 : SP\_2016\_NA0022\_350\_84\_20160304\_00059.jpg

View of the erosion on the waterward side of the levee looking upstream.  
Fall 2015.

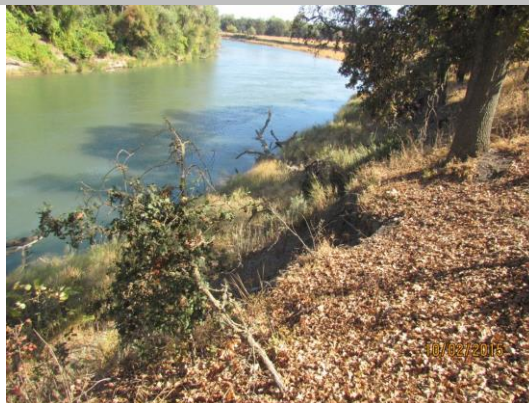
Photo 2 of 2 : SP\_2016\_NA0022\_350\_84\_20160304\_00060.jpg

View of the erosion on the waterward side of the levee looking downstream. Fall 2015.
